Rome Gearbox's

Rome offers New complete gearbox's and rebuilding services for all Weiler style grinders. Rome's gearbox cases are made of cast steel which give it more strength and allows for rebuilding of case flanges in the event that there is major bearing wear. All gearbox's come standard with class 10 gears for better strength, and are epoxy painted.

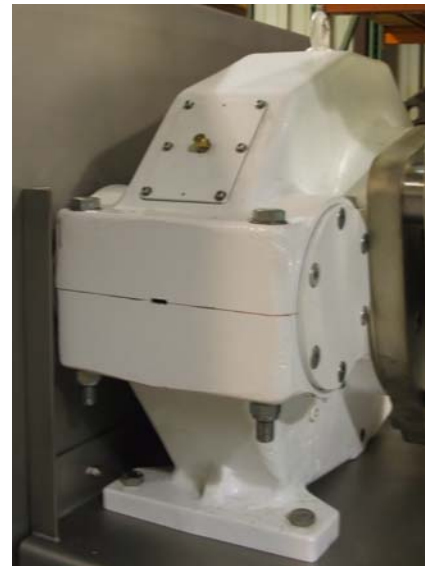
"A" Style Drive

"B" Style Drive
